ASSESSMENT OF ENVIRONMENTAL EFFECTS – ARBORICULTURE

For Charcoalblue – Eric Lawrence
Site Waikato Regional Theatre
Prepared by: Jon Redfern – Principal Consultant
Reviewed by: David Spencer – Principal Consultant
Brief: Assessment and reporting on potential effects to Scheduled trees in relation to the proposed Waikato Regional Theatre
Date July 2018

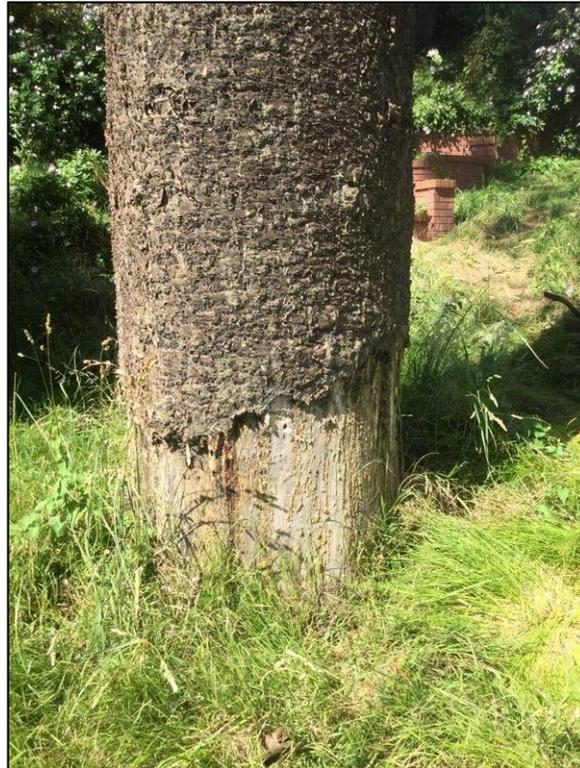
Figure 2

- 7.3.2. The trunk of the tree has been damaged with a large area of bark removed. The removed bark area extends around approximately 90% of the tree's circumference, from ground level to approximately 500mm above ground level. The remaining 10% is a column of bark that hasn't been affected. It is unknown what has caused this damage to the trunk.

- 7.3.4. The crown foliage density is visibly thinning with areas of open canopy due to foliage dieback. This indicates that the tree is in decline, which is a likely result of the cambium damage at the area of bark loss. It is unlikely, given the damage to the trunk, which has essentially ring-barked the tree, and the existing decline, the tree will recover from its current condition. In addition, there are little remediation measures that will improve the health and longevity of the tree. Overall, it has been assessed that the tree is arboriculturally compromised due to declining health.

The above photograph illustrates the bark loss at the base of the Norfolk Island Pine

- 8.3. It has been assessed that tree 16.2 – Norfolk Island Pine is of poor condition, health and is declining. As the tree declines further, it is likely that it will start to disintegrate with the loss of branches, there is also a small likelihood that the tree could fail at the rootplate. It is unlikely that this tree will recover even if remedial measures are implemented. The removal of the tree can be mitigated with replacement planting. The attributed low RNZIH score provided by Arborlab is due to the decline of the tree.

10.1. Trees 16.2, 16.4 and 16.5 are to be removed to ground level. The removal of the trees is to be undertaken by an experienced arboricultural contracting company in adherence to NZ Arb good practice guidelines. The tree removals will be undertaken in a manner that will avoid damage to the trees being retained on site. This will include avoiding any felling or dismantling where contact with the retained trees could occur and retaining machinery or vehicles on load bearing surfaces when within the tree's root protection zones.

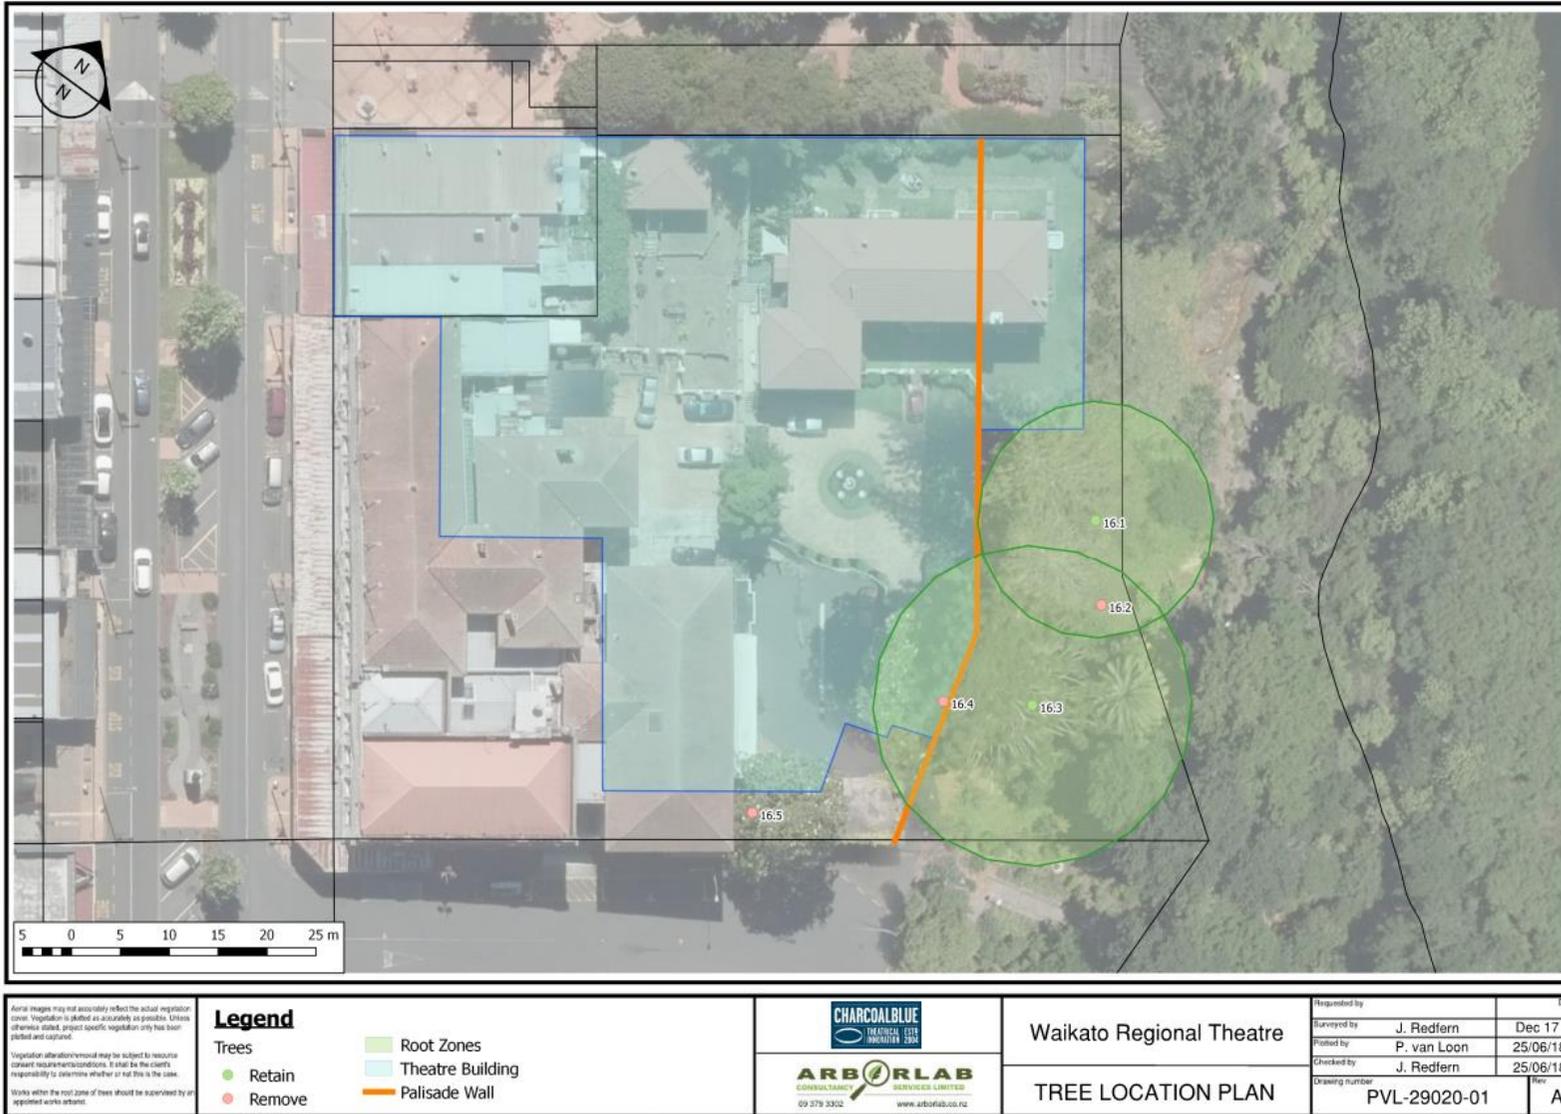
Appendix C – Theatre Plan with Tree Rootzone (not to scale)

- 8.8. It has been determined that the most appropriate application of the HCC Root Protection Zone is 9 x DBH; 'Mature trees (which the age of the tree is between 20% and 80% of life expectancy)'. This also provides an area of potential rootzone disturbance, which has been calculated to be approximately ~15% in regards to the Bunya Pine and ~2.4% of the Norfolk Island Pine. For a visual reference of the rootzones please see Appendix C of this report. British and Australian Standards recommend avoidance of incursions into a rootzone of more than 20%. Using the British and Australian standards (both use 12 x DBH) the incursion into the Bunya Pine is in excess of 18%.

- 8.9. The Theatre has reduced its footprint to provide rootzone for the trees, however, due to the size of the trees' 'Root Protection Zones' the incursion within the Bunya Pine's rootzone is significant with potential for alterations to the root growing environment. Mitigation measures and a tree management plan will need to be adhered to mitigate any potential long-term adverse effects and to maintain the trees in a healthy condition.
