Dr Caroline Phillips – Archaeological Consultant

Oral Presentation

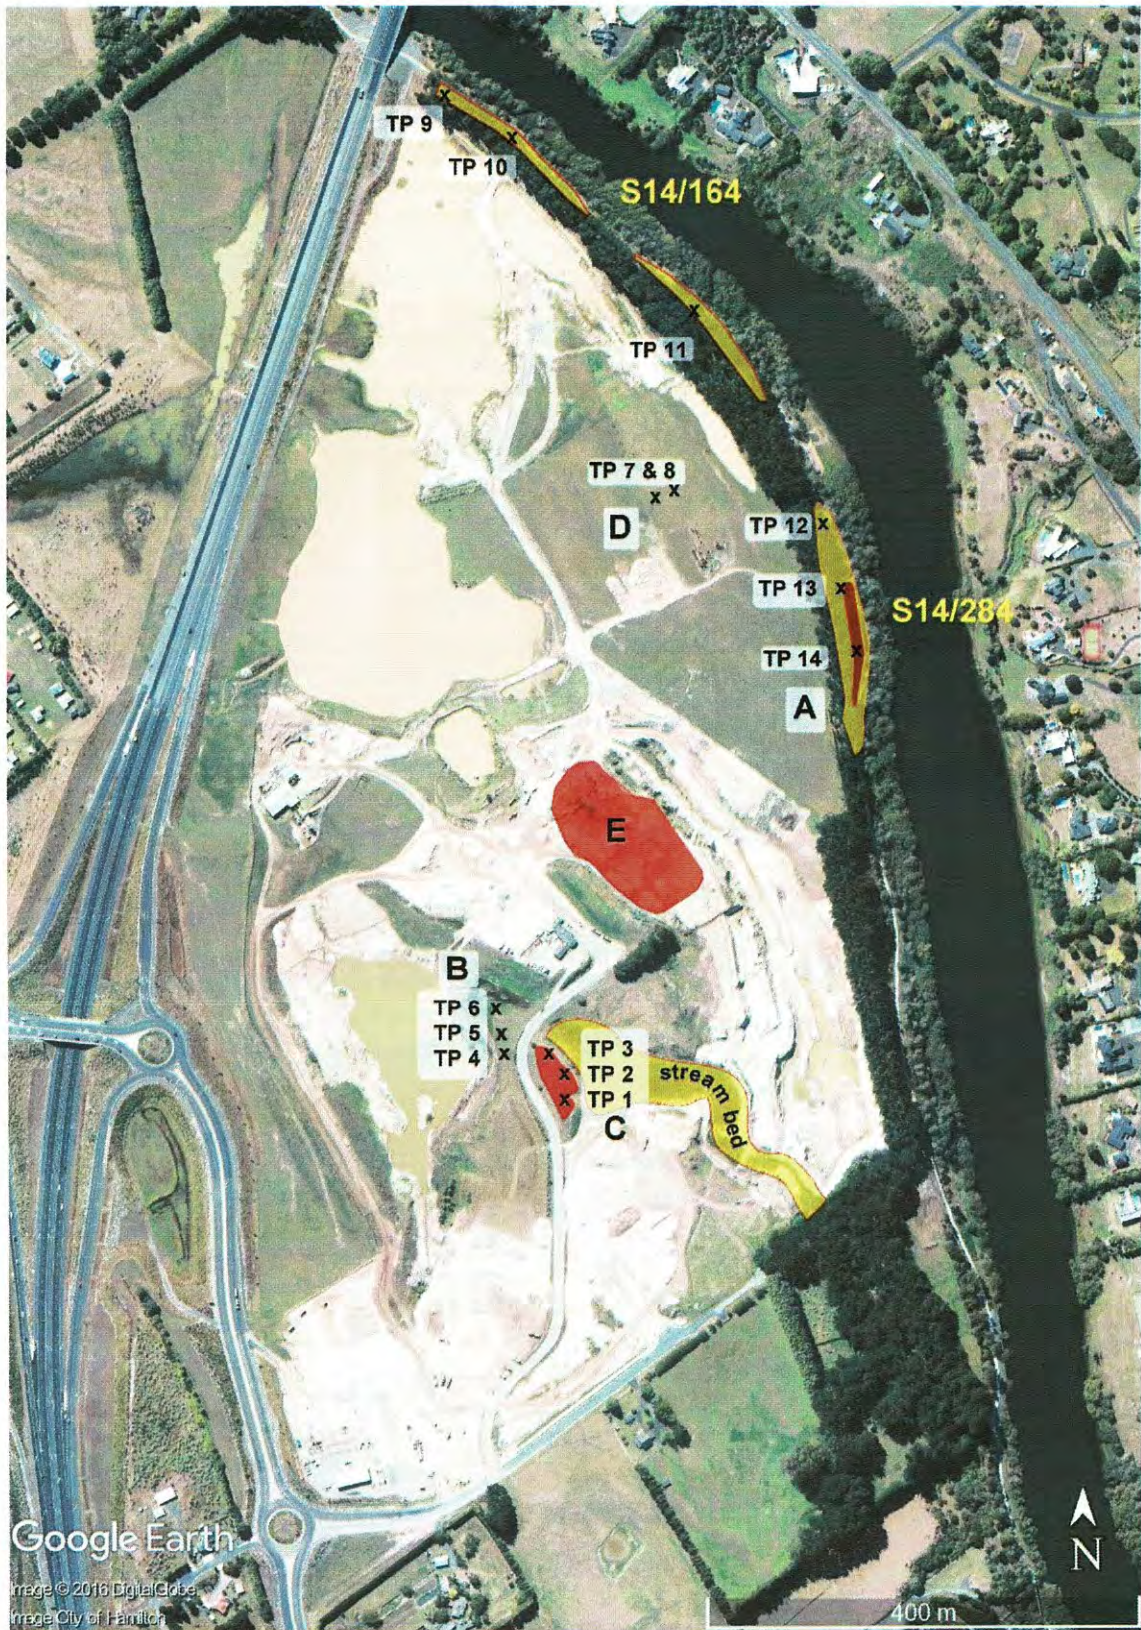
Figure 4. Location of test pits and areas where archaeological deposits may exist (red shading) with river terraces (yellow shading) (Google Earth 2015).

However, research and field tests have identified four areas where evidence of past Maori occupation may still exist on the property (Figure 4 in Statement of Evidence):

A: cooking area on river terrace, recorded as S14/284. The trees are to be removed from the terrace (the tree removal will be monitored under authority from HNZPT), after which it is to be preserved through containing it in the esplanade reserve and scheduled by council.

C high ground: above the stream valley, which has not been affected by quarrying, is likely to contain occupation evidence.

C stream channel: although the upper parts of the banks have been highly modified, the lower banks, including any swampy deposits, may contain archaeological evidence. In this case, the evidence may be: artefacts deliberately placed, or accidentally incorporated into the wetlands; paths leading down to canoe anchorages; eel traps, canoes or structures beside the stream.

E: high ground, formerly the loading area of the quarry. It was part of the extensive Maori garden site recorded as S14/164. As it has a 2m deep overburden on top of the former ground surface, it could not be tested to determine if evidence of garden soils or related activity still exist.

Areas **C high ground** and **E** are within the land to be developed, and will be destroyed by the works. In mitigation, it is intended to archaeologically excavate these areas under authority from HNZPT to recover any information that remains. Area **C stream** may also be modified, and it is intended to monitor works as required, so that information can be documented and any organic artefacts can be recovered and conserved.
