BEFORE THE HAMILTON CITY COUNCIL

FOR of an application for resource consent, for proposed demolition of the former Temple View Block Plant

**STATEMENT OF EVIDENCE OF WENDY TURVEY (HISTORIC HERITAGE)
ON BEHALF OF HAMILTON CITY COUNCIL**

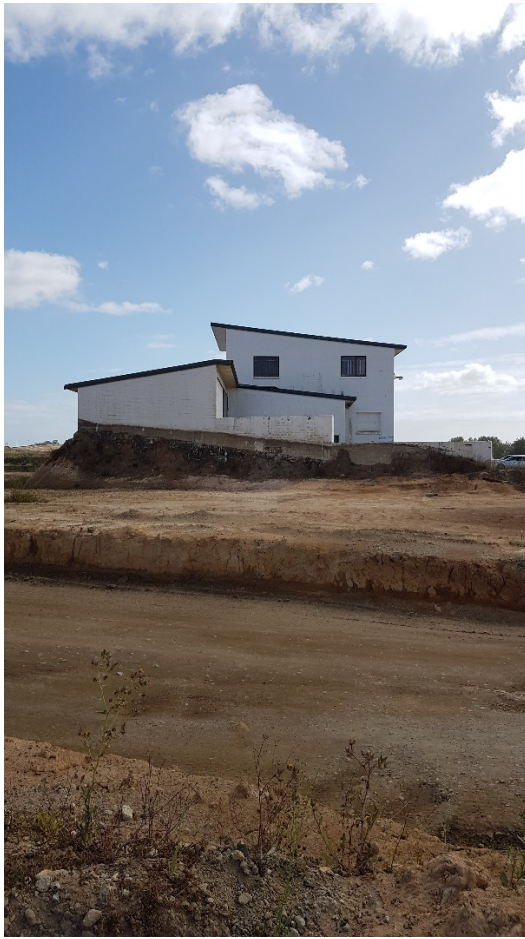
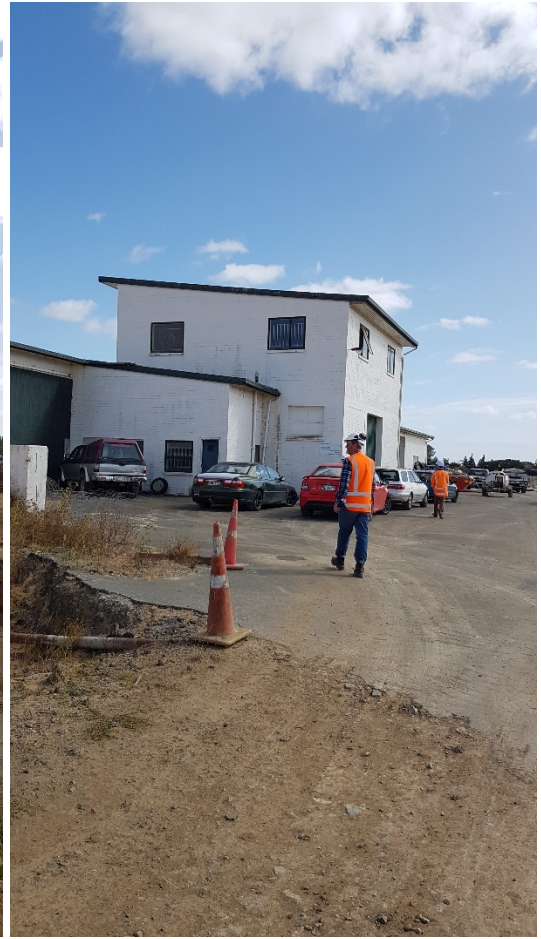
ANNEXURE A PHOTOGRAPHS

Block Plan Scale and Size

61. The scale and form of the Block Plant are such that they are not out of kilter with residential scale buildings.
62. The mitigation offered by the applicant is inadequate to address the effects of demolition of a high value heritage building.
63. The Block Plant should be retained and the application for demolition consent denied.
